Service Bulletin

| Category D | Applicable Model/s 1995-96 Millenia (S) | Subject OIL LEAKING FROM UNDER THE TIMING BELT COVER | Bulletin No. 001/96 Issued 09/09/96 Revised |

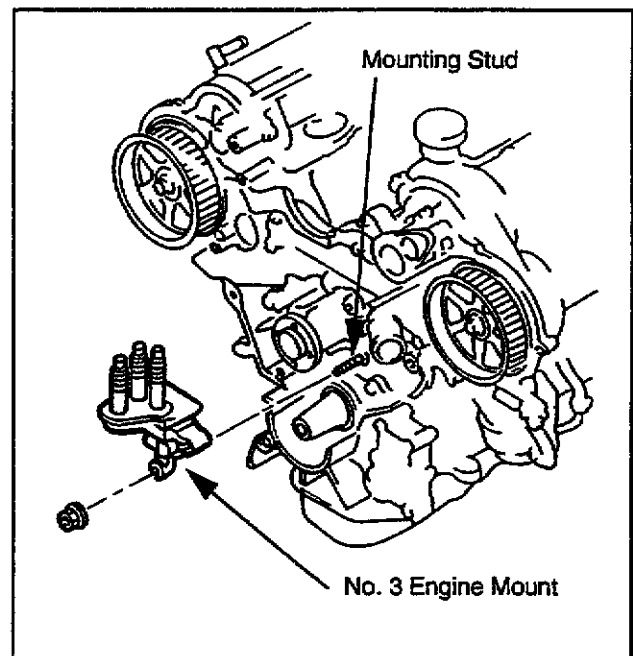
Oil may leak past the threads of the No. 3 engine mount and out of the timing belt cover. Customers complaining of this should have the vehicle inspected and repaired according to this bulletin.

1. Remove the No. 3 engine mount according to the workshop manual.
2. Remove the No. 3 engine mount bracket mounting stud from the cylinder block.

3. Clean the threads thoroughly and apply Loctite PST Pipe Sealant w/ Teflon (#565).
4. Install stud into cylinder block.

NOTE: Replace timing belt if oil contaminated.

5. Install engine mount.
6. Verify repair.
