Category G (01)	Applicable Model/s All Models except B-Series & Nav.	Subject DEAD BATTERY (INSPECTING FOR BACK-UP CURRENT)	Bulletin No. 001/98 Issued 10/22/98 Revised
--------------------	--	---	---

### DESCRIPTION

Battery is dead after vehicle sits overnight or for a short period of time. This could be caused by excessive back-up current drawn through the battery after the engine is shut off.

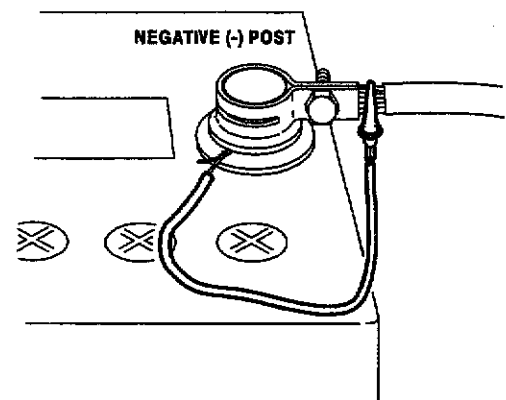
- To avoid deleting the audio memory presets or OBD-II fault memory, prepare a jumper wire as shown.
- Carefully loosen the negative battery clamp without disconnecting it from the post.

- Slightly lift clamp and wrap the jumper wire around the bottom of the post and attach the alligator clip to the cable clamp.

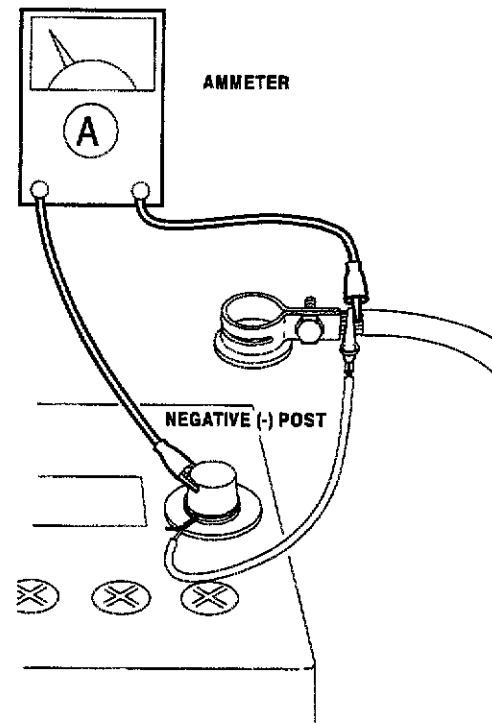
6. Remove the clamp from post then connect an ammeter as shown.

- Be sure ammeter fuse is good. If fuse is blown, it will create an open circuit which will defeat the purpose of this procedure.

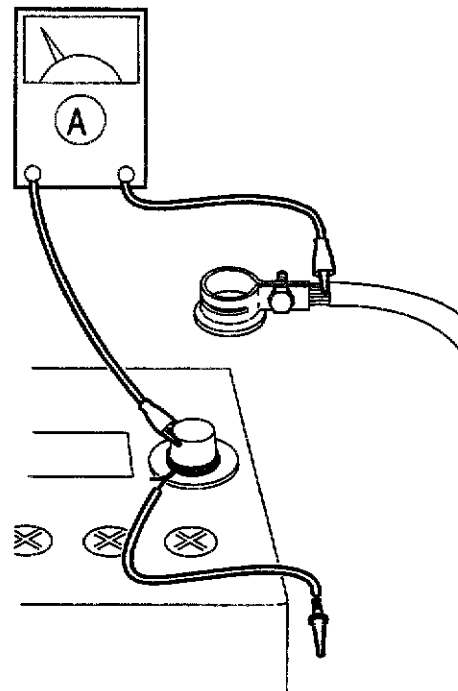
7. Remove the alligator clip from the cable clamp and measure the back-up current.

**20mA (0.020A)**

- It is necessary to wait a minimum of one (1) minute after removing the key from the ignition and closing all doors before measuring back-up current. This is the time necessary for dome lights and CPU's to shut down and back-up current to achieve specification.

If back-up current exceeds specification, a short exists or a defective component is causing excessive current flow.

Locate the source of excessive current draw and repair as necessary. Then proceed to STEP 8.
