Service Bulletin

Category T	Applicable Model/s 1995 Millenia	Subject BATTERY DISCHARGE FROM TRUNK LIGHT STAYING ON	Bulletin No. 002/94
			Issued 6/21/94
			Revised

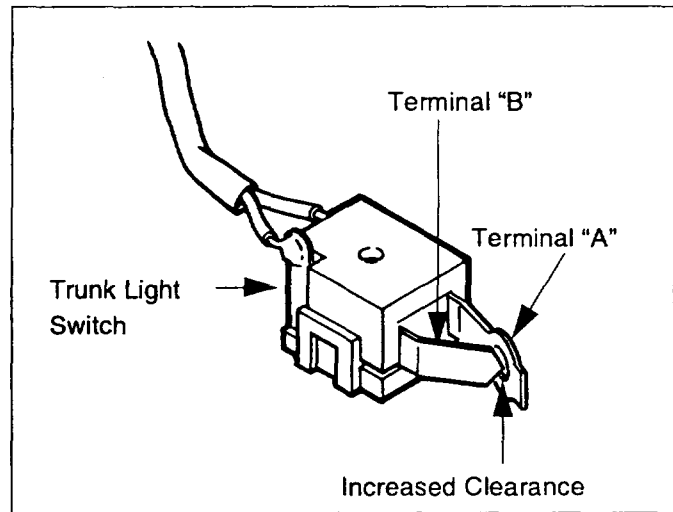
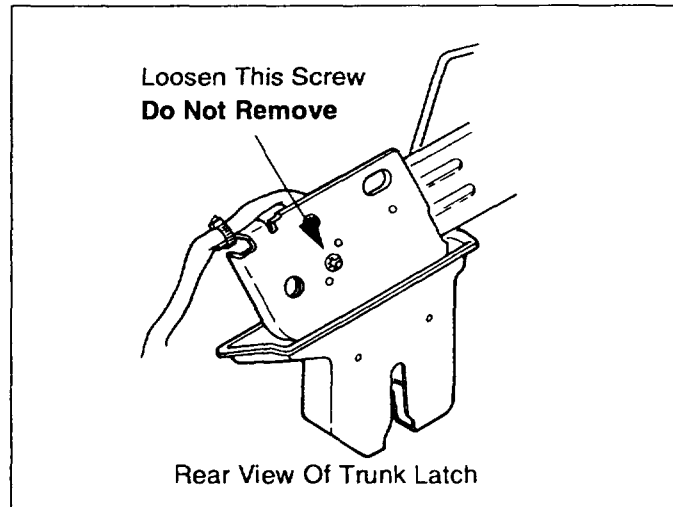
Some vehicles may have discharged batteries caused by the trunk light staying on after the trunk lid is closed. This is caused by incorrect installation of the trunk light switch.

1. Verify complaint by manually depressing the trunk light switch.
 - If the light stays on with the trunk light switch depressed, proceed to step 2.
 - If the light goes off, the problem is not in the trunk light switch. Proceed to the troubleshooting section of the workshop manual for additional information. Repair as necessary.
2. Remove the trunk lid latch and loosen the screw that secures the trunk light switch.
