Service Bulletin

Category T	Applicable Model/s 1995-97 Millenia	Subject BLOWER MOTOR FAN SPEED INCORRECT BLOWER MOTOR INOPERATIVE	Bulletin No. 002/97
			Issued 03/10/97
			Revised

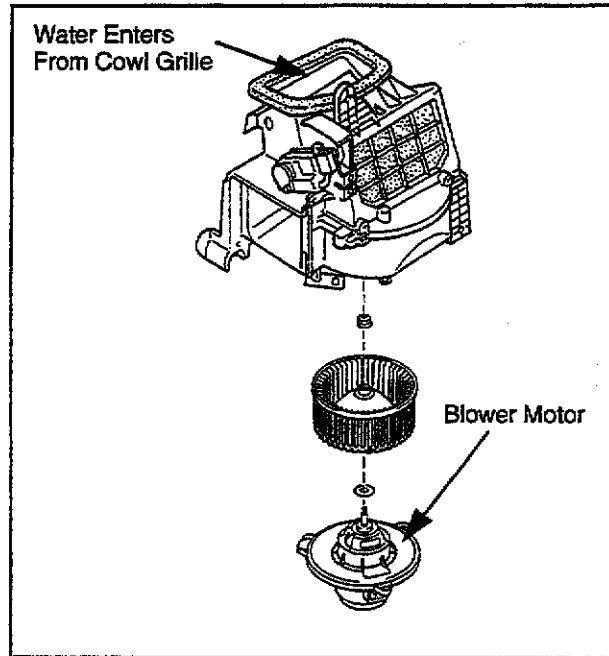
The blower motor fan speed may be incorrect or the fan is inoperative. This is caused by corrosion on the blower motor shaft created by water entering the air ducts and traveling to the blower motor from the blower motor casing.

1. Verify the concern.
2. Replace the blower motor assembly with a modified part.
3. Inspect the power transistor for proper operation. Refer to section U of the workshop manual.
4. Verify repair.
