Section <b>09</b>	Applicable Model/s <b>Multiple Models</b>	Subject <b>CIGARETTE LIGHTER DOES NOT WORK PROPERLY</b>	Bulletin No. <b>007/00</b>
			Issued <b>07/28/00</b>
			Revised

1997-2001 Protege, MPV, Miata, Millenia.

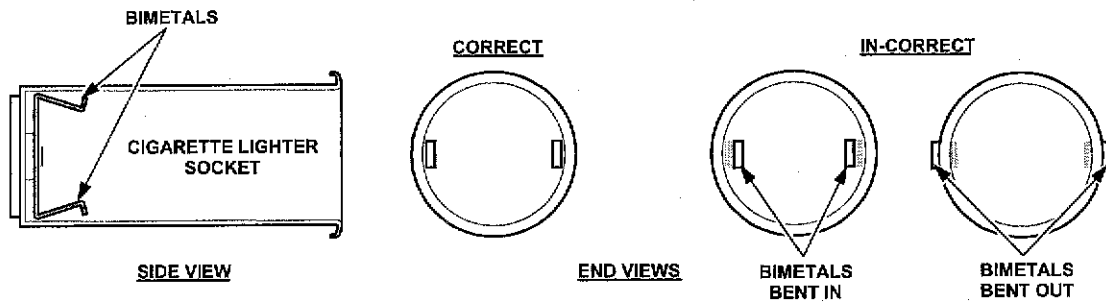
Some customers may state that their cigarette lighter does not work or stay in position. This concern can be caused by the use of an after-market cigarette lighter or a plug adapter of the wrong size for the cigarette lighter socket. As a result, the cigarette lighter socket bimetals can be bent as shown below and/or the socket retainer ring is broken.
