Category T (09)	Applicable Model/s 1995-97 Millenia	Subject FUEL/TRUNK OPENER SWITCH LOOSE	Bulletin No. 009/98
			Issued 08/05/98
			Revised

1995 - 97 Millenia with VINs lower than JM1 TA22**W1405202.

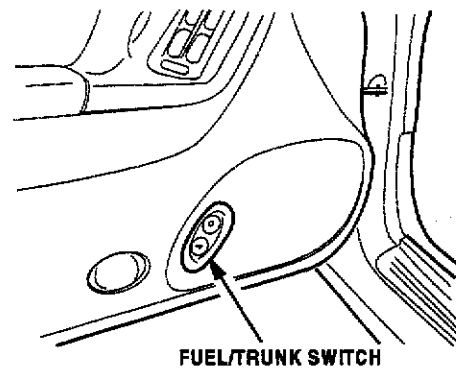
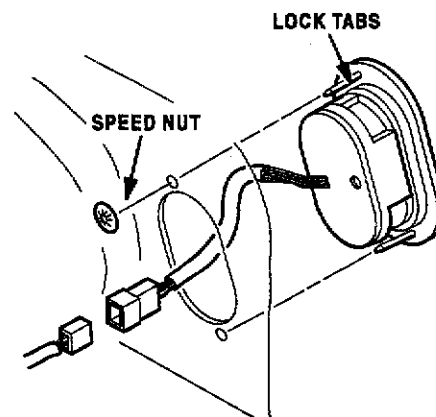
The fuel/trunk opener switch may become loose or detached from the door trim panel. This may be due to the speed nut interfering (contacting) with the switch causing the lock tab of the switch and/or speed nut being broken, loose or out of position. To correct this concern, the modified speed nut with a smaller diameter is available which prevents interference with the switch. Oil on the speed nut has also been removed to reduce cracking or breakage. Customers complaining of this concern should have their vehicle repaired according to the following procedure.

3. After door trim panel is removed, inspect the fuel/trunk switch lock tabs.

- If broken, replace the switch and use modified speed nuts.
- If not broken, replace the original speed nuts with modified ones.
