Subject: MIL OR LOW FUEL LIGHT MAY ILLUMINATE, INACCURATE/ERRATIC OPERATION OF FUEL GAUGE	Bulletin No: 01-007/01R
	Last Issued: 8/30/2002

All 1997 - 2002 Millenia

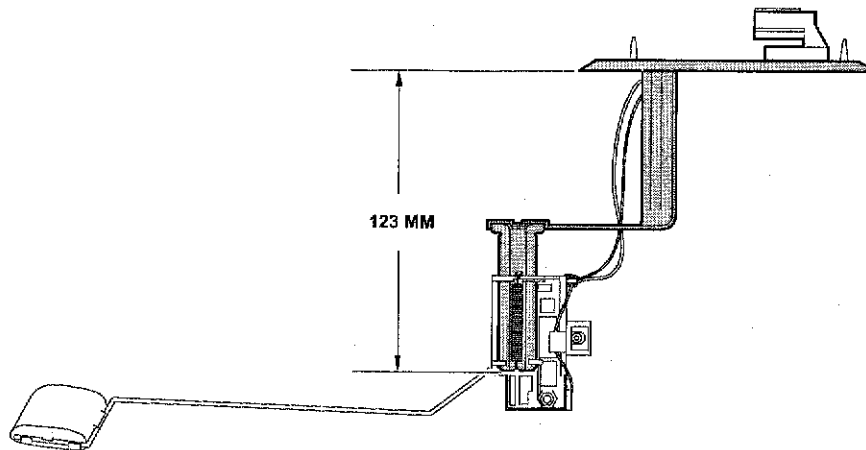
FUEL GAUGE SENDING UNIT

6. Measure distance between bottom edge of fuel gauge sender unit bracket and bottom mounting surface of mounting plate as shown in the following illustration.

- If measurement is 123mm (plus or minus 1mm) bracket is not bent. For further diagnosis refer to Service Bulletins 09-003/00R and/or F(01)-016/98.
 - If measurement is 112 to 121mm, replace fuel gauge sender unit with modified part. DO NOT replace fuel tank. Proceed to STEP 8.
 - If measurement is less than 112mm, reinstall fuel gauge sender unit back into fuel tank and proceed to STEP 7.
7. Check evaporative system for excessive vacuum using the following procedure:
- A. Warm-up engine to normal operating temperature.
 - B. Using NGS Tester, monitor PIDs for RPM, PRGV & FTPV.
 - C. With vehicle in PARK, rev fully warm engine and hold at 2800RPM for 3-4 minutes.
