MIL ILLUMINATION WITH DTC P0300 TO P0306

Bulletin No: 01-027/02

Last Issued: 11/15/2002

All 1995 - 2002 Millenia models with 2.5L V6 (KL)

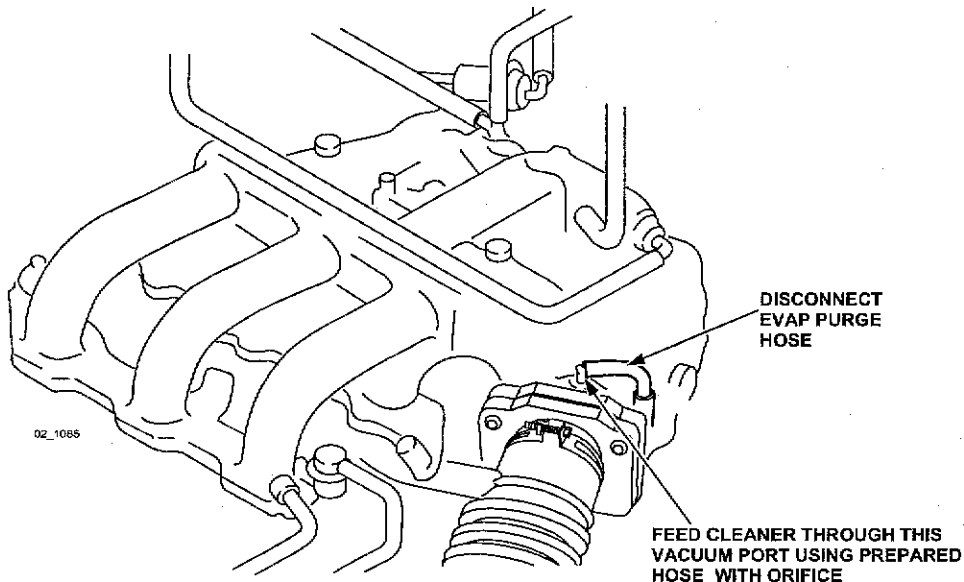
1. Warm up the engine until it reaches the normal operating temperature, then turn the ignition off.
2. Locate the canister purge vacuum port into the intake manifold to feed the cleaner into the engine. This allows the cleaner to distribute evenly.
