Category K (05)	Applicable Model/s 1995-98 Millenia	Subject ATF LEAK / ABNORMAL SHIFTING / SHIFT SHOCK	Bulletin No. 013/98
			Issued 11/04/98
			Revised

DESCRIPTION

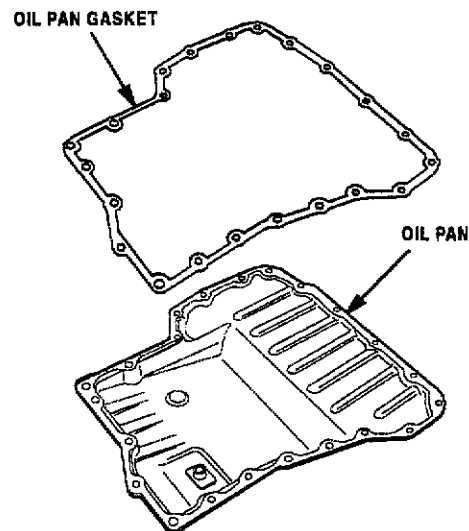
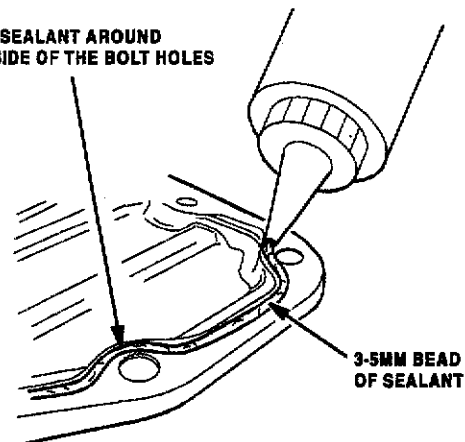
ROUTE SEALANT AROUND
THE INSIDE OF THE BOLT HOLES

6. Apply a continuous 3-5mm {0.12-0.19 in} bead of sealant along the contact surface and around the bolt holes as shown.

- Applying more sealant than recommended, may cause sealant to spill over into the oil pan.

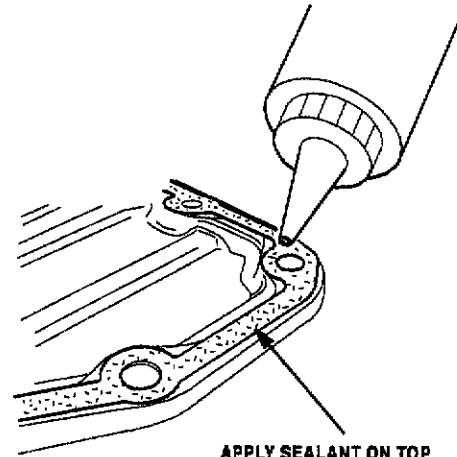
APPLY SEALANT ON TOP OF OIL PAN GASKET ALSO

7. Align and place the pan gasket in position.
8. Apply sealant to the oil pan gasket in the same way as Step 6.
9. Install oil pan and tighten new bolts gradually and evenly.

Tightening torque
6.9 - 8.8 Nm (70-90 kgf-cm, 61-78 in.-lb.)
