Service Bulletin

Category S	Applicable Model/s 1995-96 Millenia	Subject CREAKING / KNOCKING NOISE FROM REAR OF VEHICLE	Bulletin No. 014/96 Issued 04/18/96 Revised
---------------	--	--	---

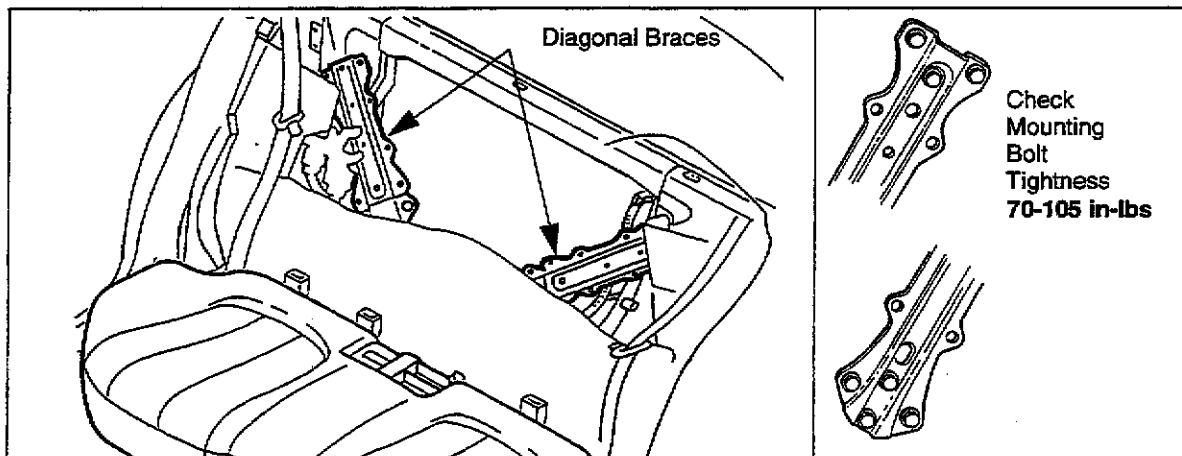
A creaking or knocking noise may be heard while driving over bumps or making turns. This noise may be caused by loose diagonal braces (behind the rear seat).

1. Verify the concern.
 - If the noise is coming from the rear of the vehicle as described above, proceed to step 2.
 - If the noise is not coming from the rear of the vehicle or is not consistent with the symptoms described above, refer to the NVH manual or workshop manual for troubleshooting and repair instructions.
2. Remove the rear seat and inspect the right and left diagonal braces for tightness.
 - If the three (3) upper or four (4) lower mounting bolts are loose, torque to **70-105 in-lbs.**
 - If the mounting bolts are not loose, refer to the NVH or workshop manual for troubleshooting and repair instructions.
3. Road test the vehicle to verify the repair.
