CREAK/SQUEAK NOISE FROM REAR SUSPENSION

Bulletin No: 02-002/01

Last Issued: 02/28/2000

All 1995-2000 Millenia.

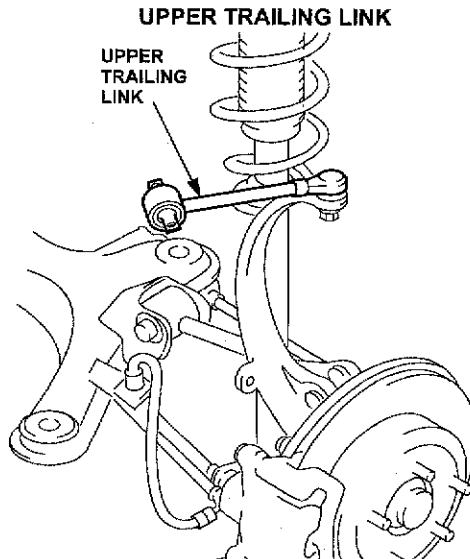
When driving at slow speeds, entering driveways, driving over speed bumps in parking lots, or driving on rough roads, a creak or squeak noise may be heard from the rear suspension. This noise may be caused from lack of lubrication at the ball joint area of the upper trailing link(s). The noise may also be heard by pushing down on the rear of the vehicle when stopped. An improved part with an increased diameter ball joint and improved lubricant is available to resolve this concern.

1. Verify customer concern.
2. Remove both rear upper trailing links and determine if noise is still present. Refer to Workshop Manual (02-14).

- If noise is not present, replace both upper trailing links with the modified part.
