# Service Bulletin

Category <b>S</b>	Applicable Model/s <b>1995 Millenia</b>	Subject <b>REAR SEAT BACK RATTLE</b>	Bulletin No. <b>022/95</b>
			Issued <b>7/19/95</b>
			Revised

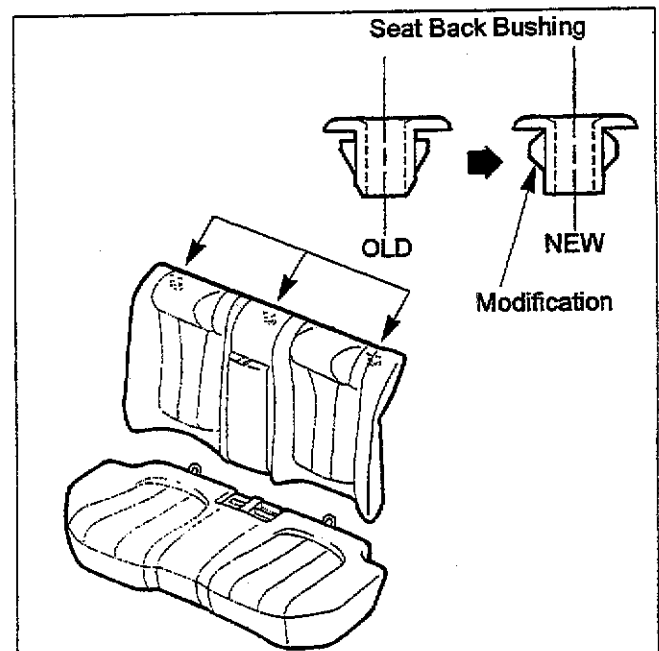
A rattle noise may be heard around the rear seat back when traveling on rough roads. This noise is caused by the seat back bushing. To prevent this noise, the bushing has been modified as shown below.

1. Verify that the noise is coming from the seat back by applying pressure to the bushing area while the noise is occurring.
  - If the noise is coming from an area other than the seat back, refer to the workshop manual for troubleshooting and repair instructions.
2. Replace the seat back bushings (3 areas).
3. Confirm repair.
