Service Bulletin

Category S	Applicable Model/s 1995 Millenia	Subject ROOF INSULATOR PEELING OFF	Bulletin No.	023/94
			Issued	6/10/94
			Revised	7/15/94

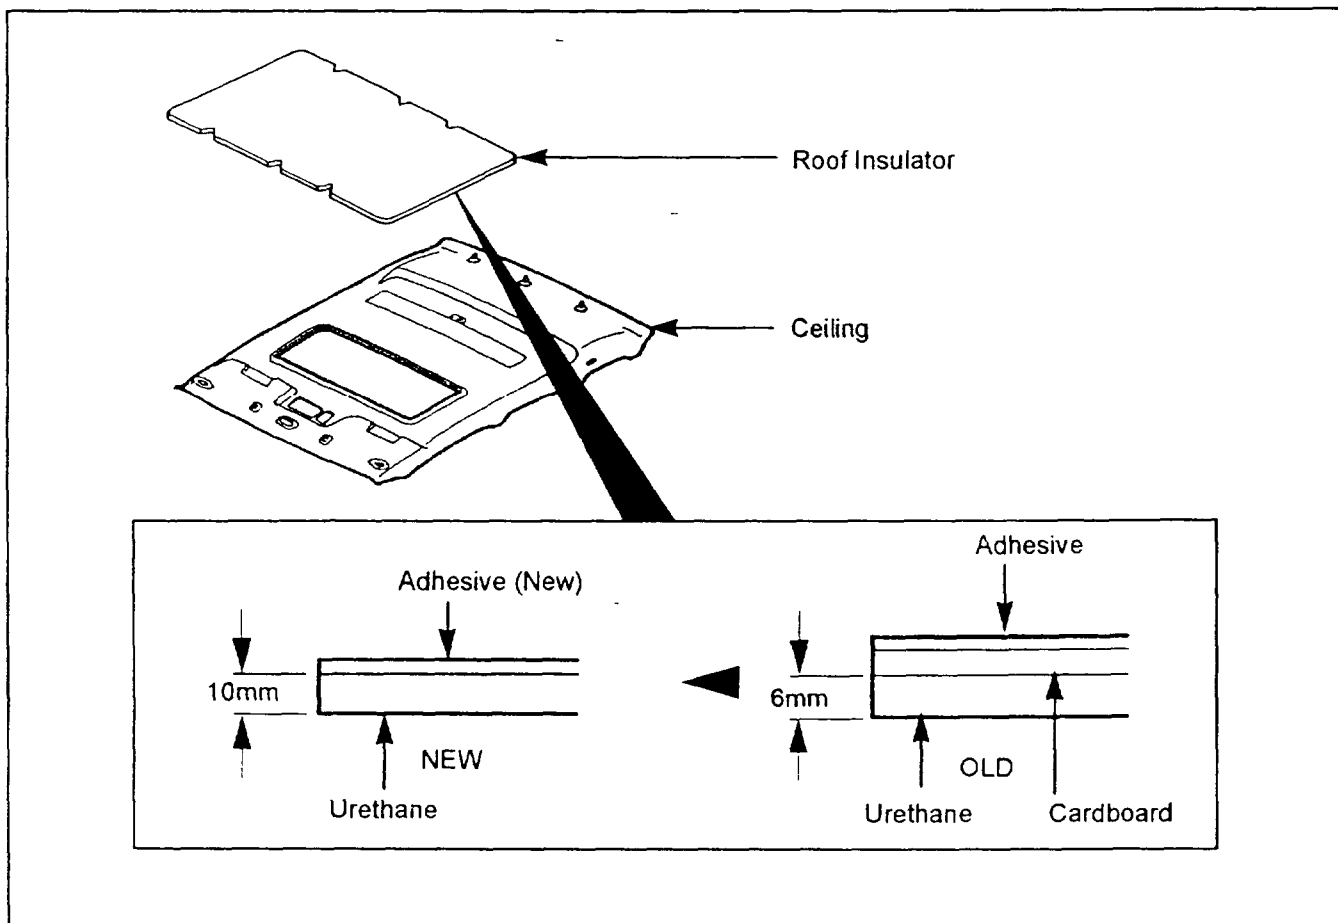
The roof insulator in the top of the ceiling may peel away from the roof panel. This condition may result in the insulator hanging down in some areas and restricting the operation of the sun shade or sun roof.

To prevent this condition, the cardboard layer between the roof panel and the adhesive has been eliminated. To improve noise insulation and adhesive properties, the thickness of the roof insulator has been increased from 6mm to 10mm and the adhesive changed (see illustration below).
