Service Bulletin

Category S	Applicable Model/s 1995-96 Millenia	Subject POWER SEATS WILL NOT MOVE FORWARD	Bulletin No. 035/96 Issued 07/24/96 Revised
---------------	--	--	---

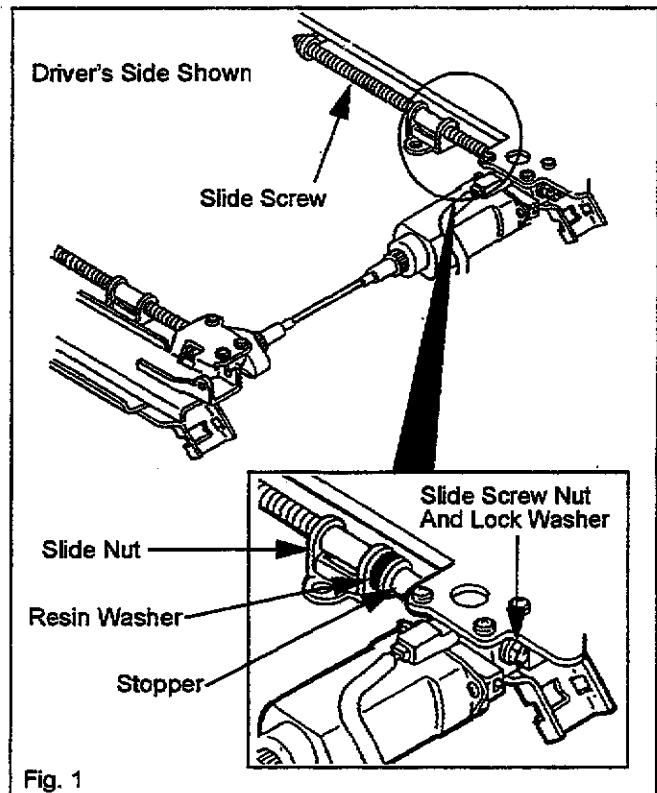
The seat bottom on some driver and passenger power seats may not move forward when operating the power seat switch. This concern does not affect the other functions of the power seat. This concern occurs when the seat is parked in the full rearward position for long periods of time (i.e. dealer inventory, storage etc.) In this position, the resin washer may become stuck to the slide nut preventing seat movement. The material used to produce the resin washer is now harder and resistant to sticking.

1. Verify the concern.
2. Apply forward pressure to the seat back and press the power seat button in the forward direction.
 - If the seat moves forward; release the pressure and operate the seat through the full range (back - forward - back).
 - If the seat does not move, proceed to step 3 on page 2 of 2.
