# Service Bulletin

Category S	Applicable Model/s 1995 Millenia	Subject CUP HOLDER OPERATION	Bulletin No. 039/94
			Issued 12/23/94
			Revised

1995 Millenia vehicles with a VIN of JM1TA22\*\*S118593 and lower

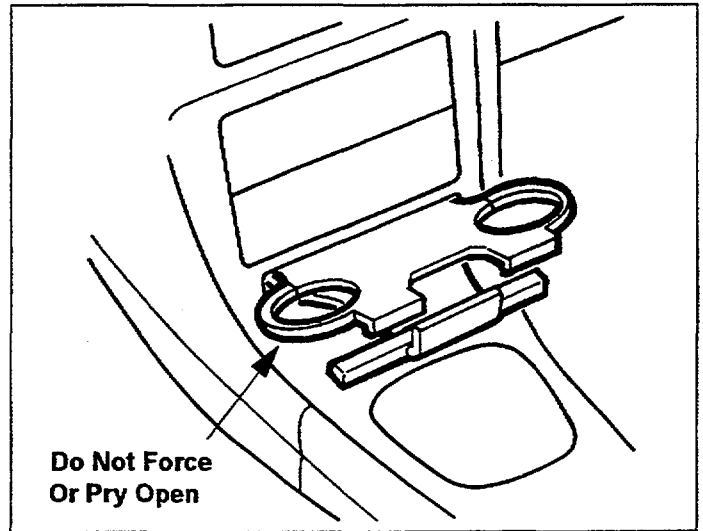
The cup holder may not open completely or may move roughly during operation. The configuration of the spring has been changed to improve the cup holder performance.

1. Verify complaint.
2. Remove the center panel (p/n T002 55 210).
3. Remove the cup holder from the center panel and replace with a modified holder.
4. Install center panel assembly.
5. Verify repair.
