# Service Bulletin

| Category<br>S | Applicable Model/s<br>1995-96 Millenia | Subject<br>GLOVE BOX LID DOES NOT FIT FLUSH<br>WITH DASH BOARD SURFACE | Bulletin No. 041/96 |
| | | | Issued 09/23/96 |

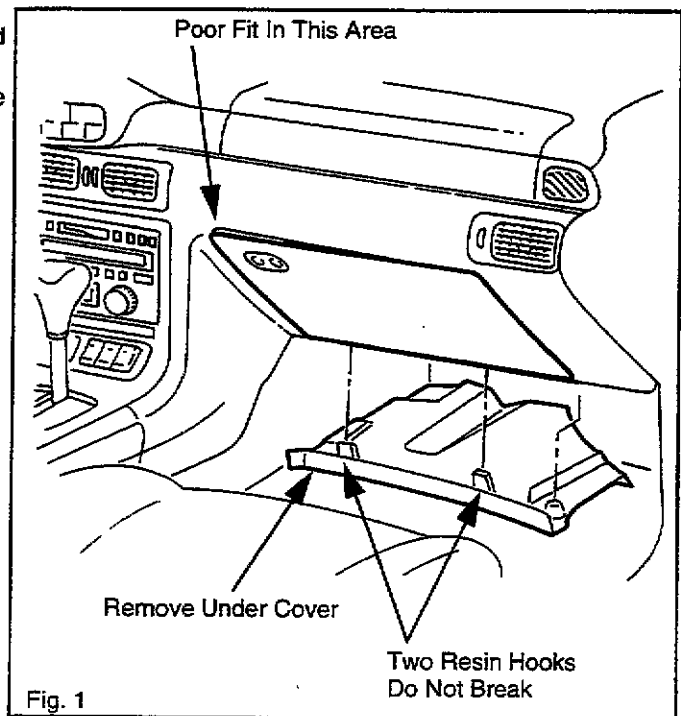
**NOTE:** When removing the under cover, take precautions not to break the two (2) resin hooks at the rear of the under cover. Refer to Fig. 1.

1. Remove the under cover right side screw and under cover.

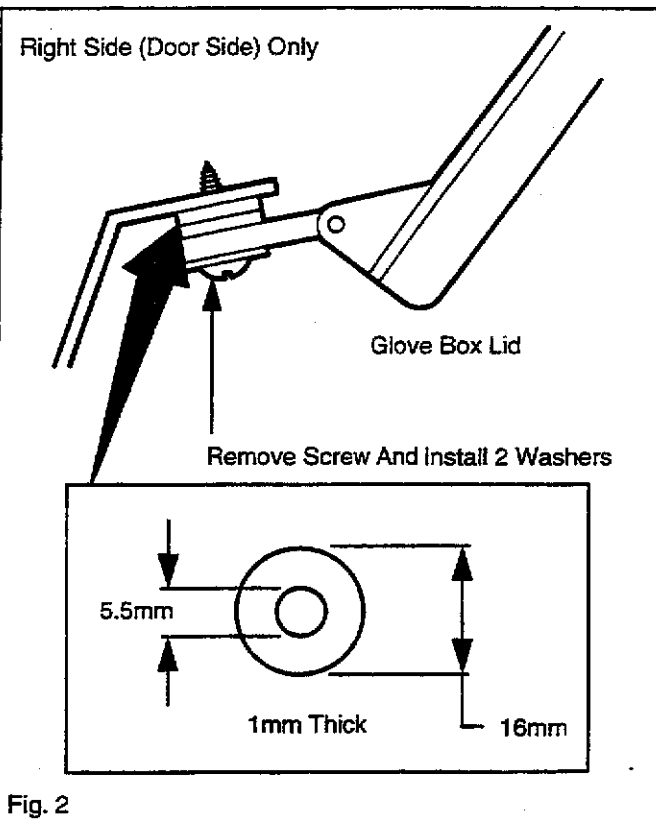
The glove box lid may not fit flush (left side lifting) with the dash board when the lid is closed. This condition is caused by the glove box compartment cushion rubber. The elasticity of the cushion rubber pushes the glove box compartment outward.

2. Remove the right side (door side) glove box compartment hinge screw.
3. Insert two (2) washers between the hinge and the bracket.
  - Retighten screws.
4. Close the glove box lid and verify proper fit.
  - If the problem still exists, adjust the number of washers until proper fit is achieved.
