Subject: TRANSMISSION WHINE/RINGING NOISE	Bulletin No: 05-001/01
	Last Issued: 04/26/2001

All 1999-2001 Millenia KJ and KL with VINs lower than JM1 TA**** 11 618514.

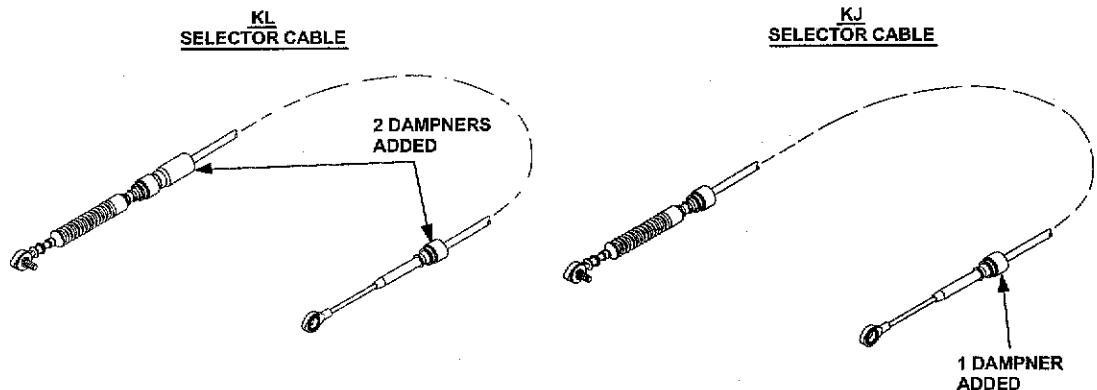
When driving at speeds of 40-70 MPH, a whine or ringing type noise may be heard inside the vehicle during slight acceleration or cruise conditions. This noise is being transmitted inside the cabin through the transmission selector cable. To help reduce this noise, a damper(s) has been added to the selector cable as shown. This noise may appear to be coming from instrument panel/dashboard area.

Note: This noise may appear to be coming from instrument panel/dashboard area.

Customers having this concern should have their vehicle repaired using the following procedure.
