<b>Subject:</b>  TILT STEERING WHEEL INOPERATIVE	<b>Bulletin No:</b> 06-001/01R1
	<b>Last Issued:</b> 11/1/2001

All 1997- 2002 Millenia.

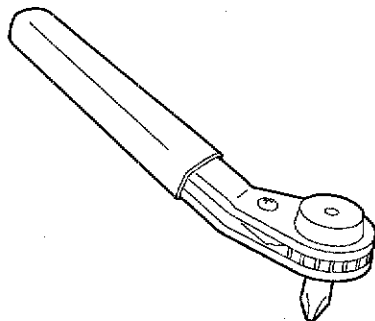
**Note:** If screws can not be loosened, use needle-nose type vise-grips to break screws loose.

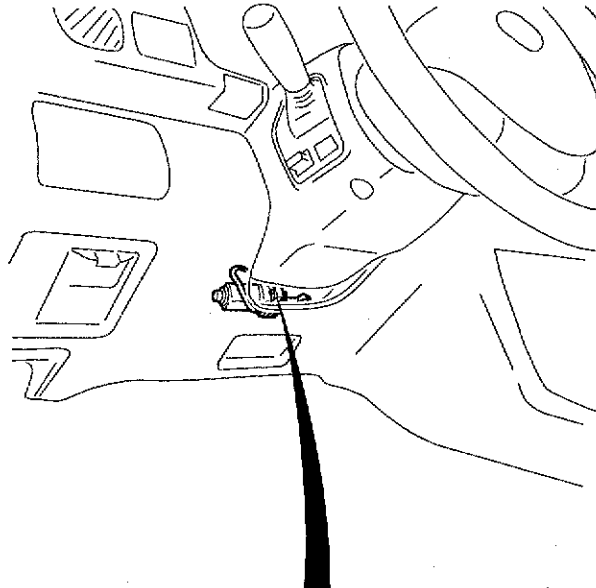
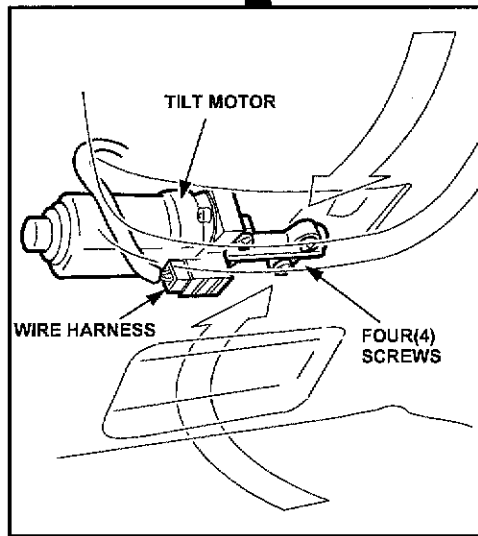
**TILT MOTOR CONNECTOR**  
**(MOTOR SIDE)**

A. Inspect for continuity between the tilt motor terminals as shown in the following illustration.

- If there is no continuity, proceed to STEP 7.
  - If there is continuity, refer to DIAGNOSIS CHART in section 06-15 of the Workshop Manual for troubleshooting information.
7. Install new tilt motor using supplied screws.
- Note:** Make sure that new tilt motor fits flush on mounting surface. If motor does not fit flush, turn motor gear slightly by applying battery voltage to either terminal.
8. Reconnect tilt motor wire harness.
9. Tighten new tilt motor mounting screws.
- Tightening torque:**
- 2.5 Nm, 25.5 kgf cm, 22.2 in. lbf.
10. Reconnect negative battery cable.
11. Program radio presets.
12. Verify repair.
