Subject: COOLING UNIT ASSEMBLY LEAKS WATER	Bulletin No: 07-001/02R
	Last Issued: 12/11/2002

All 2001-2002 Millenia

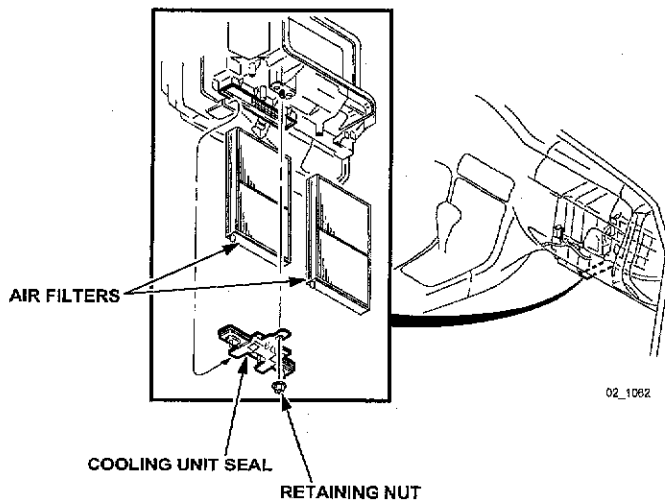
Customer complains of water leaking from under the passenger side dashboard near the footwell area. The possible cause may be due to a deformed rubber seal at the bottom of the cooling unit filter assembly, causing the water to leak at the bottom instead of exiting through the outside drain.

1. Remove the lower cover under the passenger side dashboard.
2. Remove the retaining nut and the cooling unit seal piece, which covers the air filter access slot.

3. Position a new cooling unit seal into place and tighten the retaining nut to 9-13 in.lbs. (1.0-1.5 N.m)
