Service Bulletin

Category S	Applicable Model/s 1995 Millenia	Subject CENTER SUNVISOR HOLDER CRACKED	Bulletin No. 015/96
			Issued 04/18/96
			Revised 05/15/96

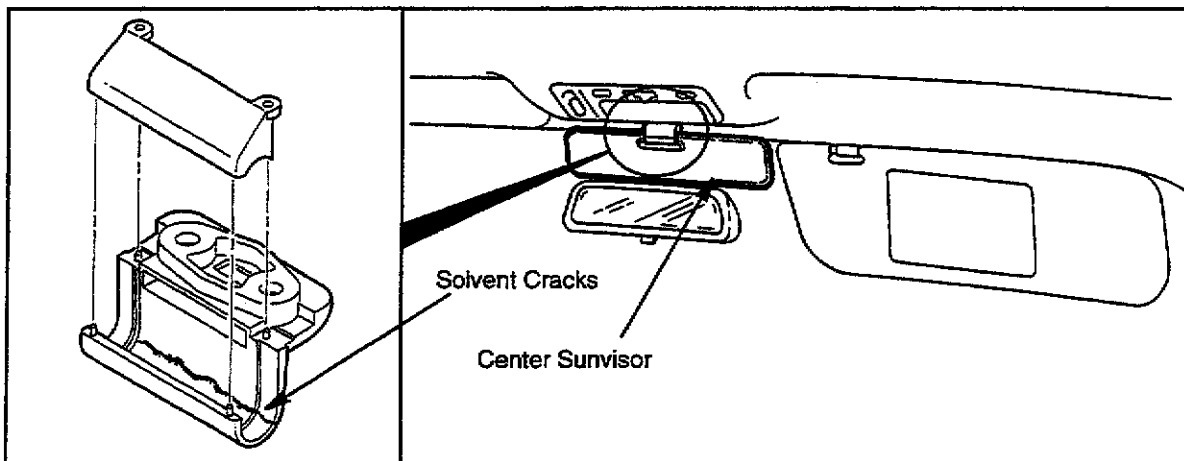
When positioning the sunvisor, the center sunvisor holder may crack.

Ultra-violet rays deteriorates the grease applied to the holder. This deterioration results in a solvent crack across the center sunvisor holder.

1. Verify concern.
2. Replace the holder.
