Subject: AUDIO REMOVAL - ELECTRICAL SHORT/DAMAGE TO PRINTED CIRCUIT	Bulletin No: 09-007/01
	Last Issued: 10/4/2001

Vehicles equipped with Modular Audio System

- 2001 & 2002 Millenia
- 2001 & 2002 626
- 2001 & 2002 Miata
- 2001 & 2002 Protege

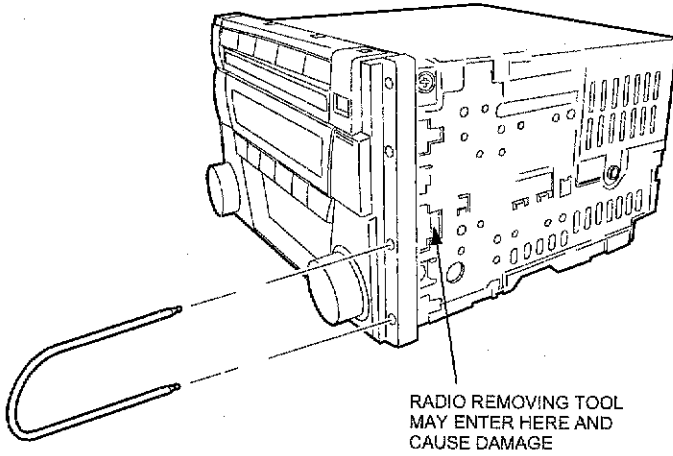
3. Insert radio removing tools into access holes according to Workshop Manual (section 09-20 AUDIO UNIT REMOVAL).

CAUTION: To avoid damage to the radio's printed circuit plate, insert radio removing tools only as far as

previously made marks {7/8" (22 mm)} in STEP 2.
